## Got Asbestos? Overcoming Obstacles in Construction Projects

Anthony Price  
Senior Consultant

Russell Snyders  
Principal Consultant

**EORM**<sup>®</sup>  
a BSI Professional Services Company

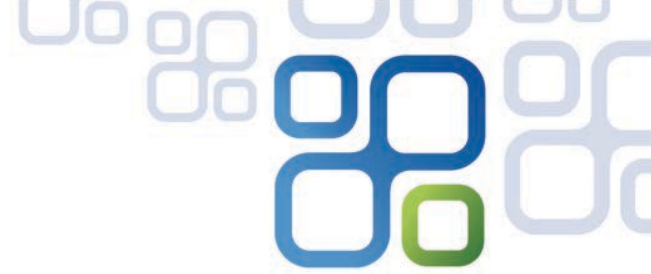
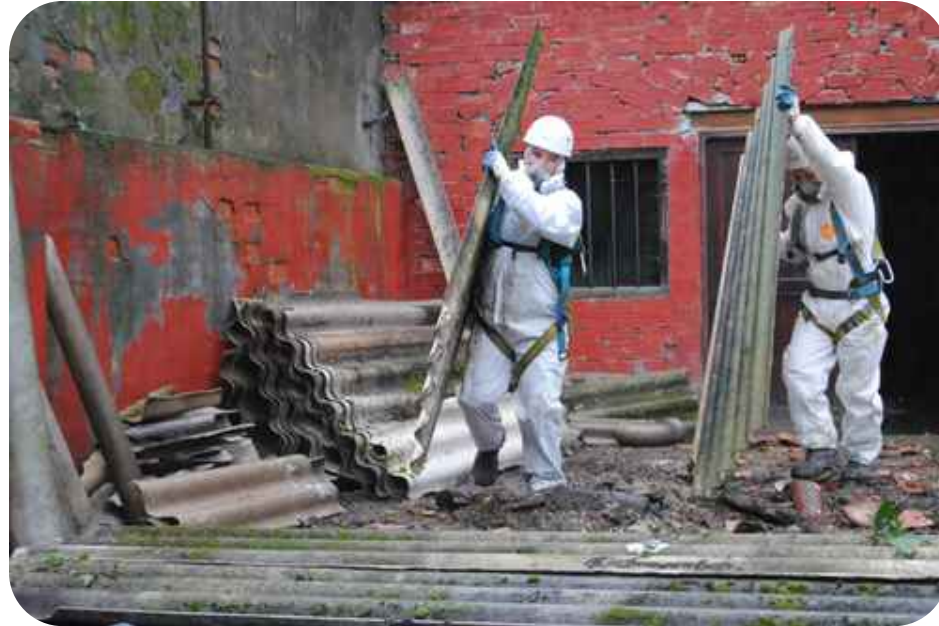
# Asbestos Abatement

- Typical Interior
  - Poly vinyl containment
    - » HEPA filter air machine(s) for negative air environment
      - Exhausts to exterior of building
    - » Decontamination chambers (clean, shower, dirty/equipment rooms)
  - Wet method – no dry removal allowed (rare exceptions)
  - Personal Protective Equipment (PPE) for workers
  - Double bagged, generator information labeled, waste

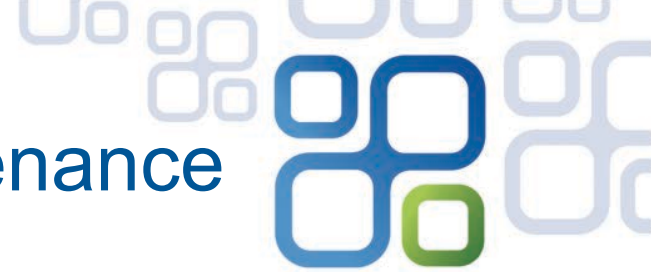
- Managing ACMs in place
  - Prevent damage and deterioration
  - Periodically inspect:
    - » Crack, scrapes, water staining, missing material, debris/dust under ACM
  - Keep away from known/suspect ACM:
    - » Do not lean/hang/brush/sand/drill etc.
    - » Avoid air or physical contact
  - Preventing exposures
    - » Follow safe work practices – Do not disturb ACM
    - » Avoid damaged and/or friable ACM
    - » Report damage or disturbance

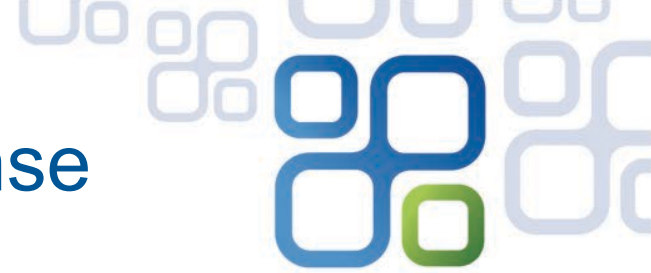
- Real Case
- Asbestos-containing fireproofing
- Asbestos-containing joint compound on gypsum wallboard system
- Asbestos-containing wall texture
- Asbestos-containing black mastic on floor

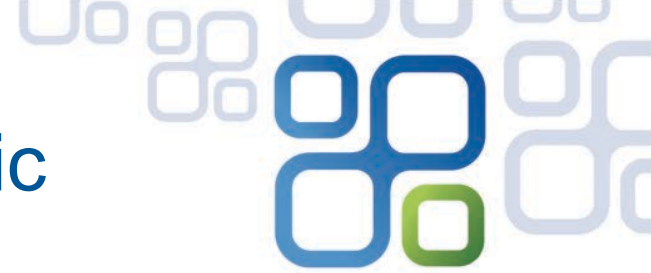
- Many methods of abatement, not all removal
  - Chemical removal
  - Bead blasting
  - Grinding
  - Razor Scraping and float
